TCEQ Interoffice Memorandum

Date: September 13, 2017

Subject: TX07087 – Armadillo Drive Dam

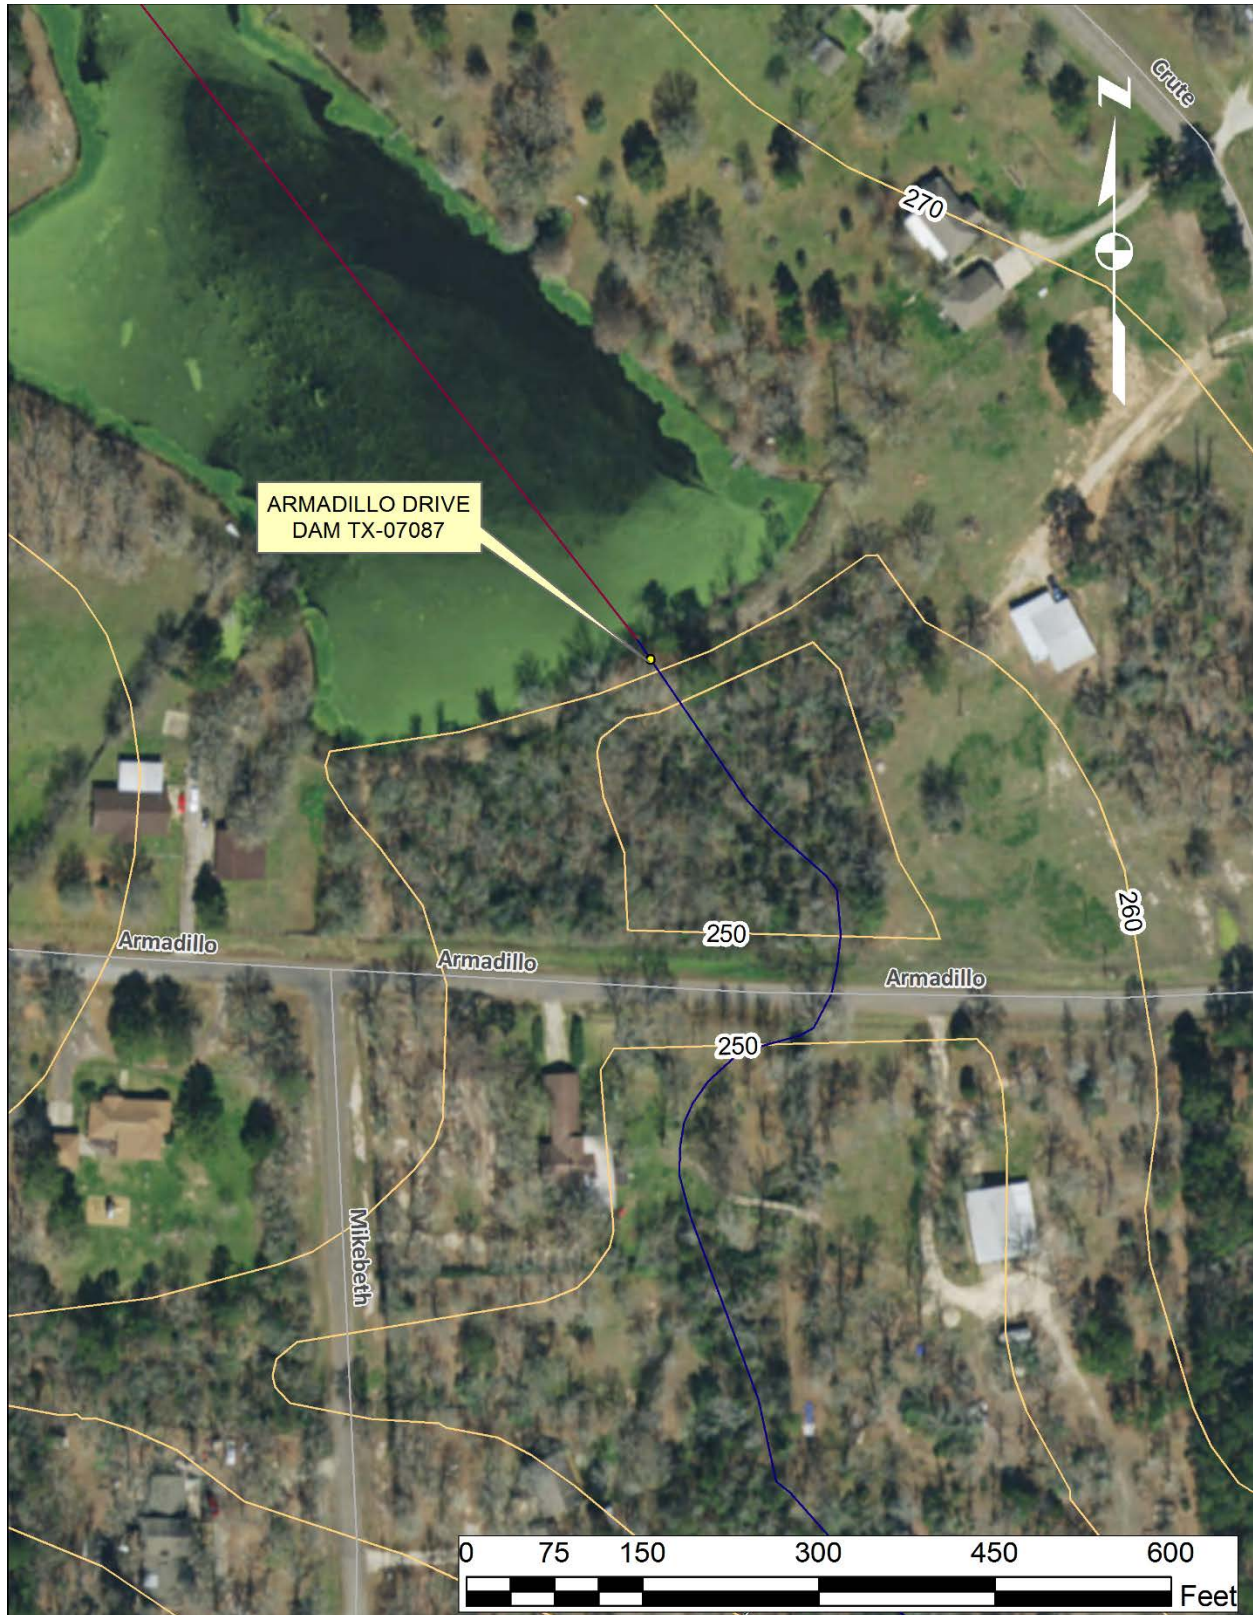
Figure 1—Aerial View (2016)
Armadillo Drive Dam - 10' Contours

The following observations were noted as shown in the attached figure and photos: matted grass and minor erosion indicated overtopping at the left end of the embankment along the access path to the street downstream of the dam. A sinkhole approximately 1-ft in diameter and 2.5-ft deep was observed near the midpoint of the crest (was located left of and not in line with the service spillway pipe). The owner indicated another sinkhole occurred but was not observed during this inspection. Based on the debris line at a nearby picket fence, the water surface appeared to crest at about 1-ft over the top of the dam (**See Photos 1-8**). At the time of the inspection, the lake level was observed to be at the approximate elevation of the service spillway drop inlet (normal level). It appeared that a wooden cover had been weighted down over the top of the service spillway inlet (possibly to keep debris from entering the pipe inlet). The service spillway outlet was not closely observed as this area was overgrown. No damage was noted to the emergency spillway, or roadway and culvert located approximately 200-ft downstream of the dam.

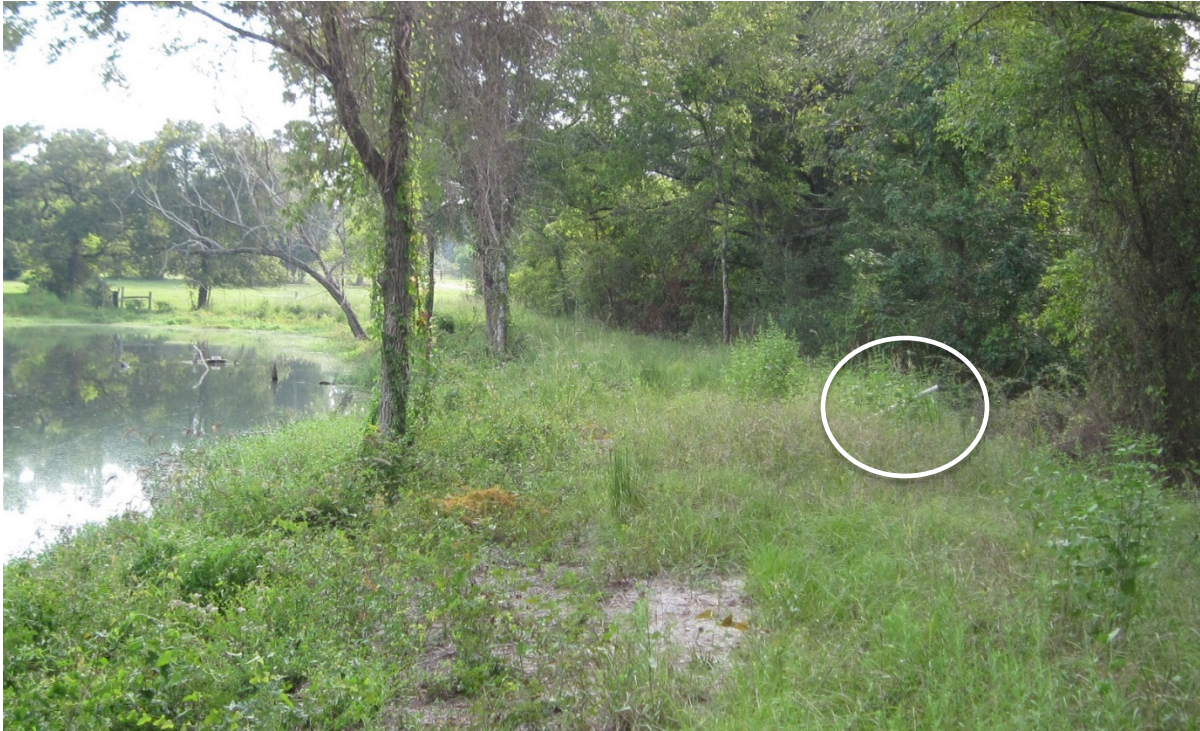
Photo 1: View of crest looking northeast. Note the circled area is where a rod was placed noting the small sinkhole.

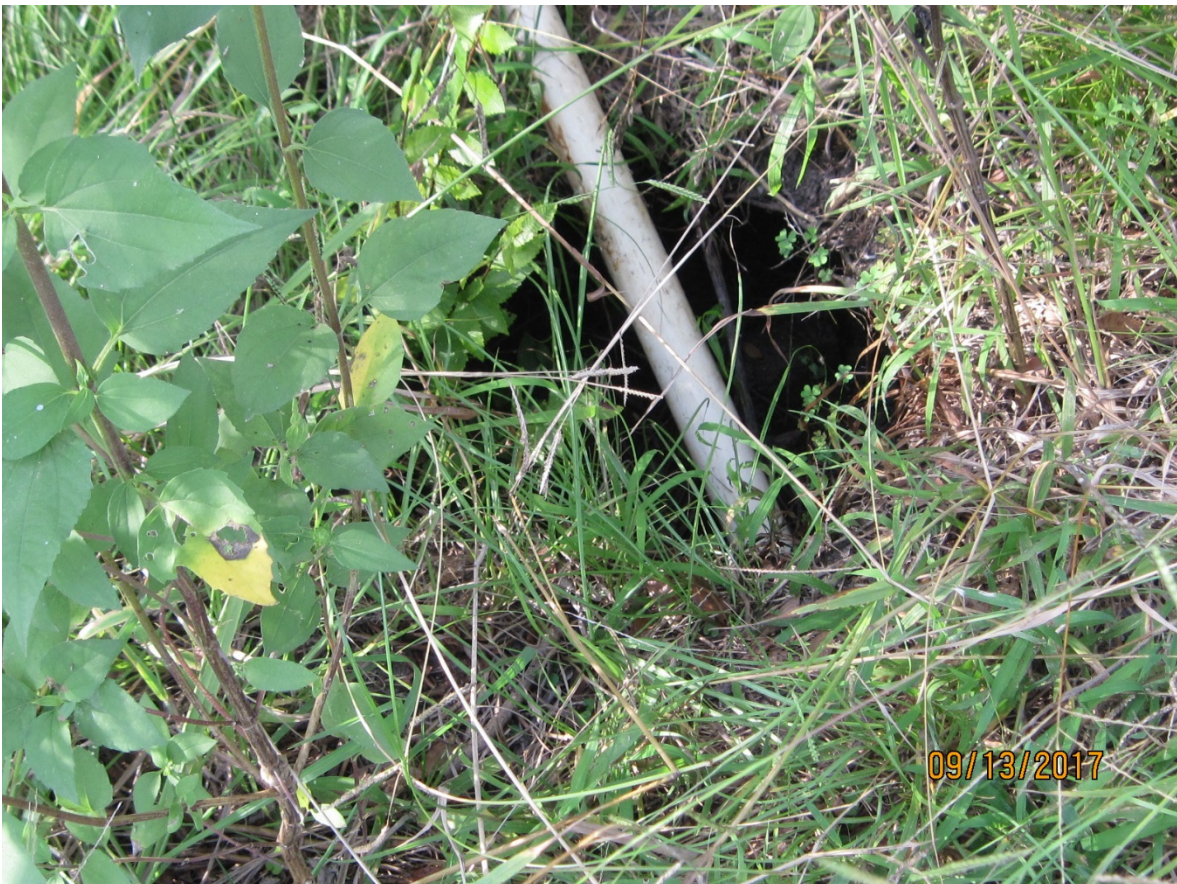
Photo 2: Close up view of the sinkhole on the crest near the mid-section of the dam. The sinkhole was estimated at 1-ft wide by approximately 2.5-ft deep.

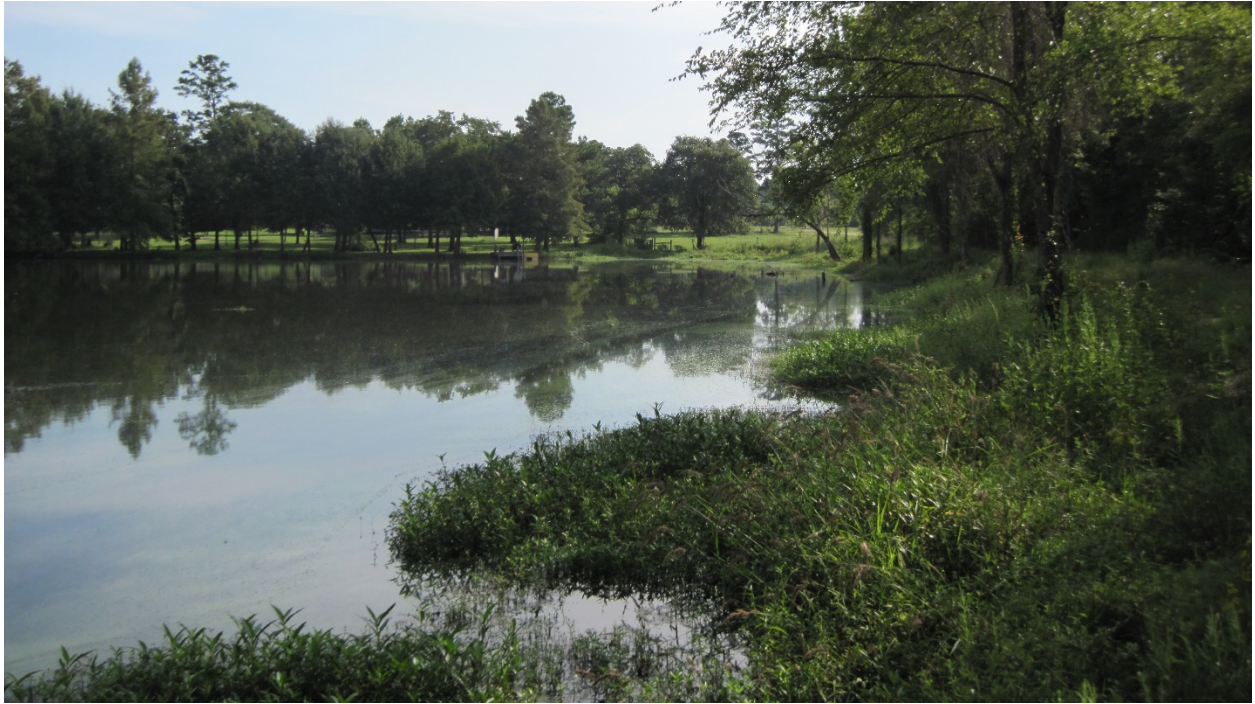
Photo 3 View of the reservoir and upstream slope at the right end of the dam looking northeast.

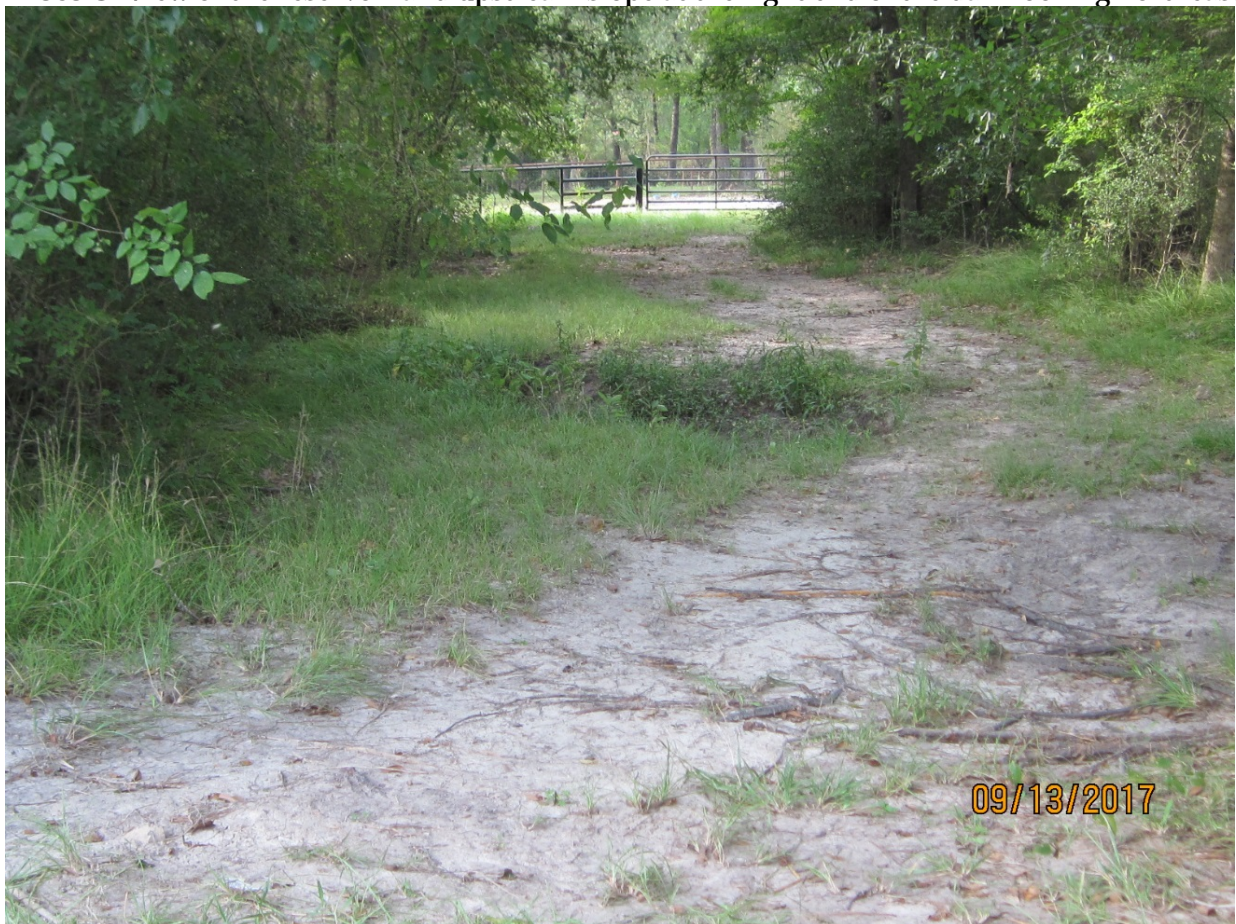
The owner was not present during the inspection but one of the downstream neighbors stated that the storm event was approximately 30 inches of rain over a 3 day period and that water did overtop the embankment. There was evidence of overtopping along the edge of the right side of the dam (grass was matted and minor erosion was noted along a path from the dam to the access gate). The owner also stated that overtopping occurred along the left edge of the embankment but no clear evidence was observed as the area had tall grass and shrubs and no erosion was noted. Lastly, the neighbor immediately downstream of the dam, noted that during the storm floodwaters were out of the natural channel banks (with floodwater approximately 200-ft wide). However, the floodwaters did not encroach upon the downstream residence.

Photo 4: View of the access path (right side of the dam) from the toe of the downstream slope looking back toward the road (South). Note the evidence of overtopping at this location as there is some matting of the grass and erosion.

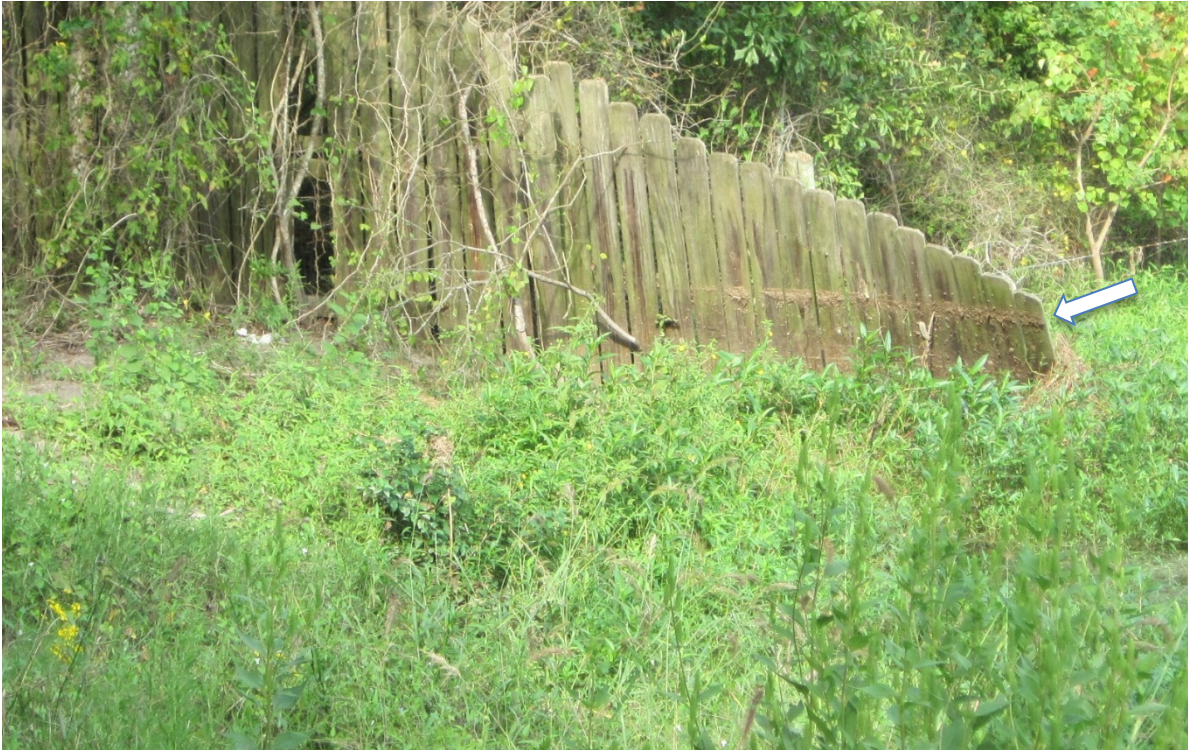
Photo 5: View of a picket fence along the right side of the dam looking southwest. Note the debris line along the fence indicates the water level crested at about 1-ft above the top of dam.

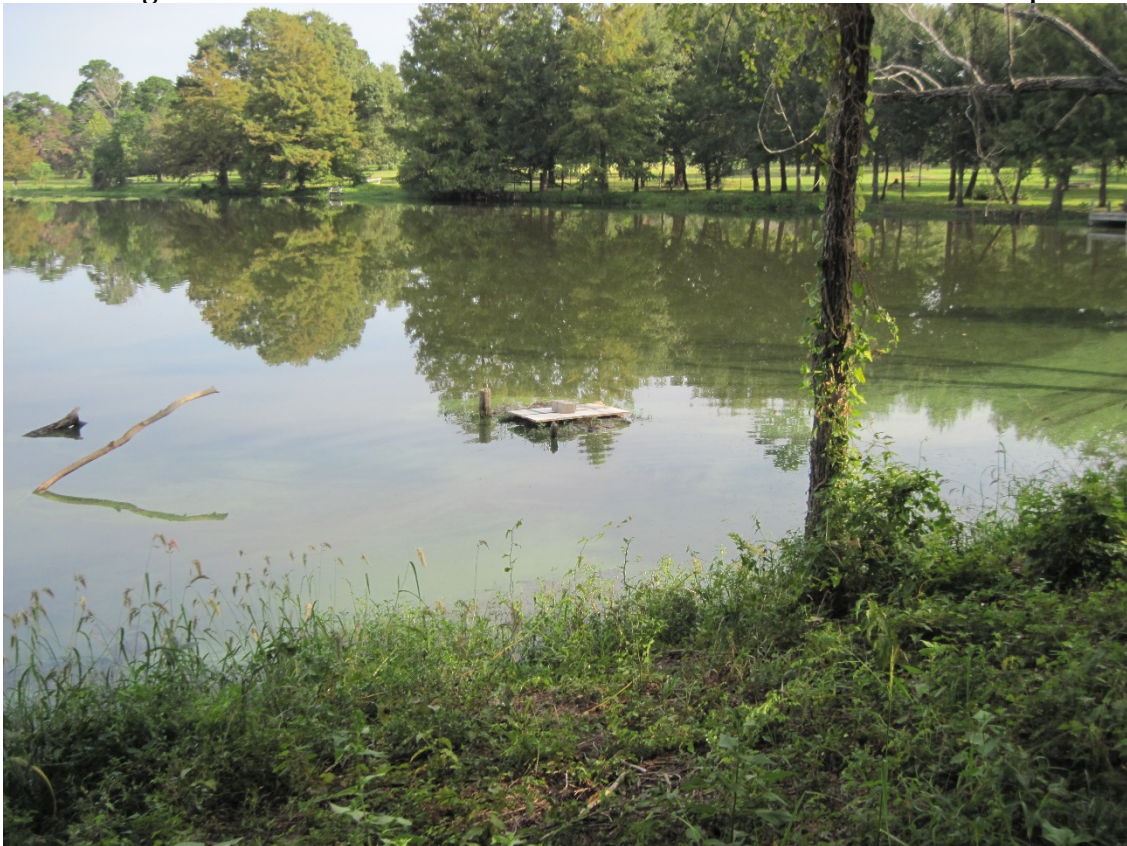
Photo 6: View of the service spillway inlet looking north with what appears to be a weighted wooden cover over the inlet.

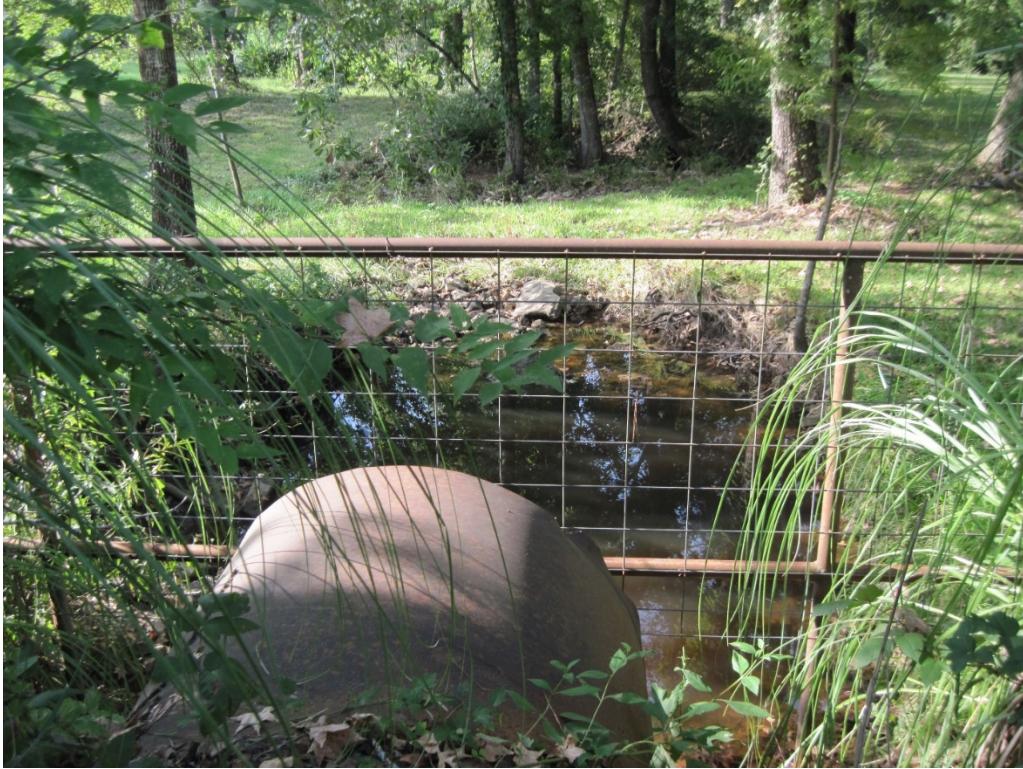
Photo 7: View of the culvert at Armadillo Drive (approximately 200-ft downstream of the dam) looking downstream (South). No damage, sediment, or significant erosion was noted.

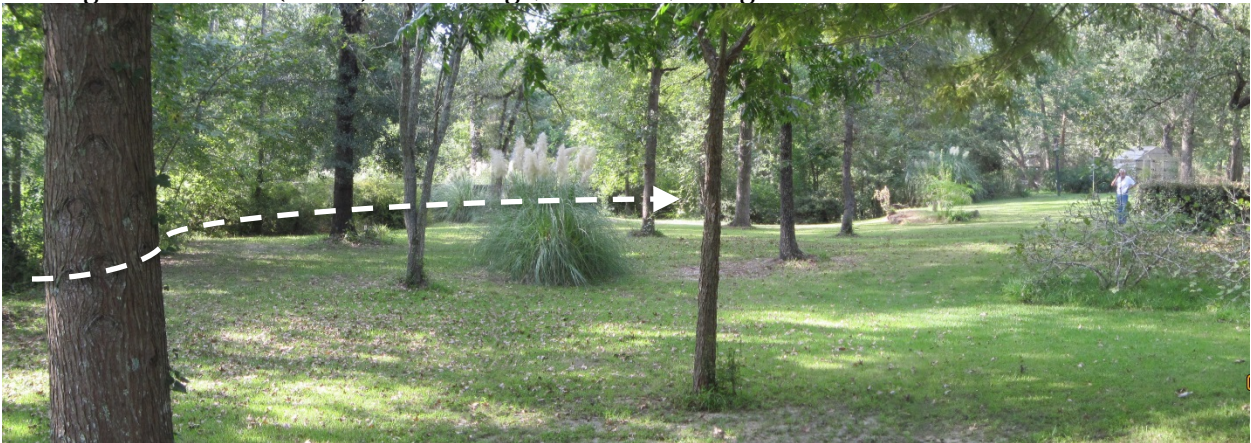
Photo 8: Panoramic view of the downstream property looking south. Note the main channel is highlighted by the dashed arrow in this photo. Per the downstream neighbor, the floodwaters extended about 200-ft wide but did not impact the residence (just to the right of the photo).
